# Green Bay Fire Department Edgewood Analysis Team Incident #5747 Final Report

# FINAL REPORT #5747

438 Edgewood Drive, Green Bay, Wisconsin

August 13, 2006

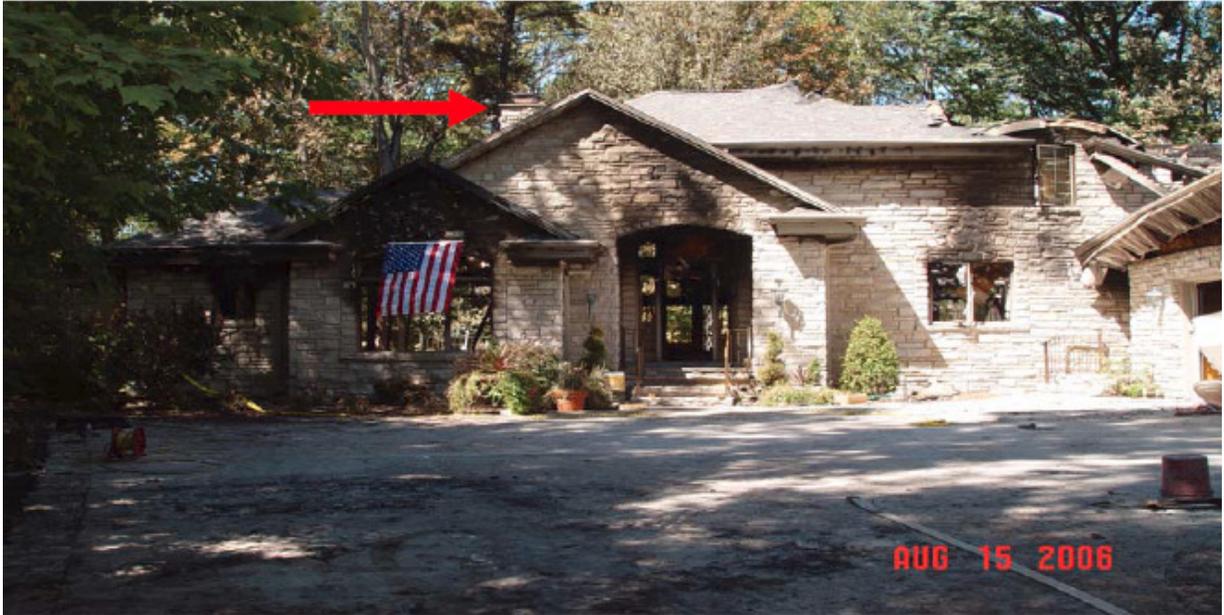
The photograph above shows the south side of the structure. The window covered by the American Flag is the office window which is on the south side of the hall way to the Master bedroom. The front entry door is where both entry teams entered before going left and right once inside the doorway. The red arrow above shows the fireplace chimney for the living room and basement. The work bench is located on the west side of that chimney in the basement. This is also the chimney that had moved due to settling after the fire.

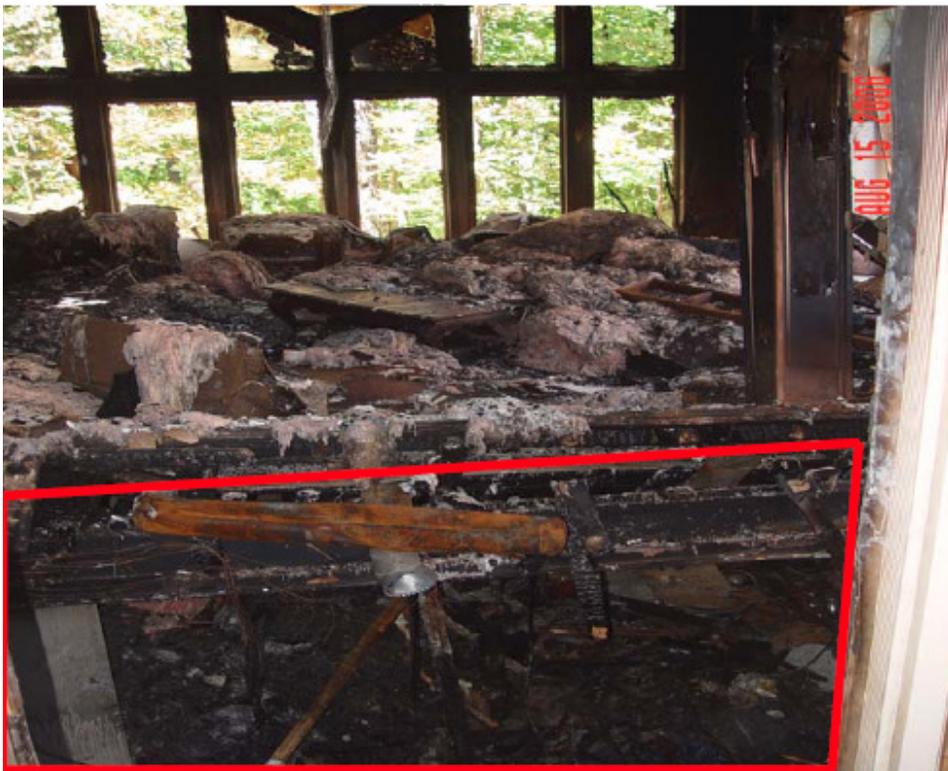
The photograph at the left shows just inside of the front doorway. The red box is where the foyer floor had been. Behind the foyer floor is the sunken living room. This doorway is the point where one entry team went right and the other entry team went left. Objects in the basement can be observed inside the red box.

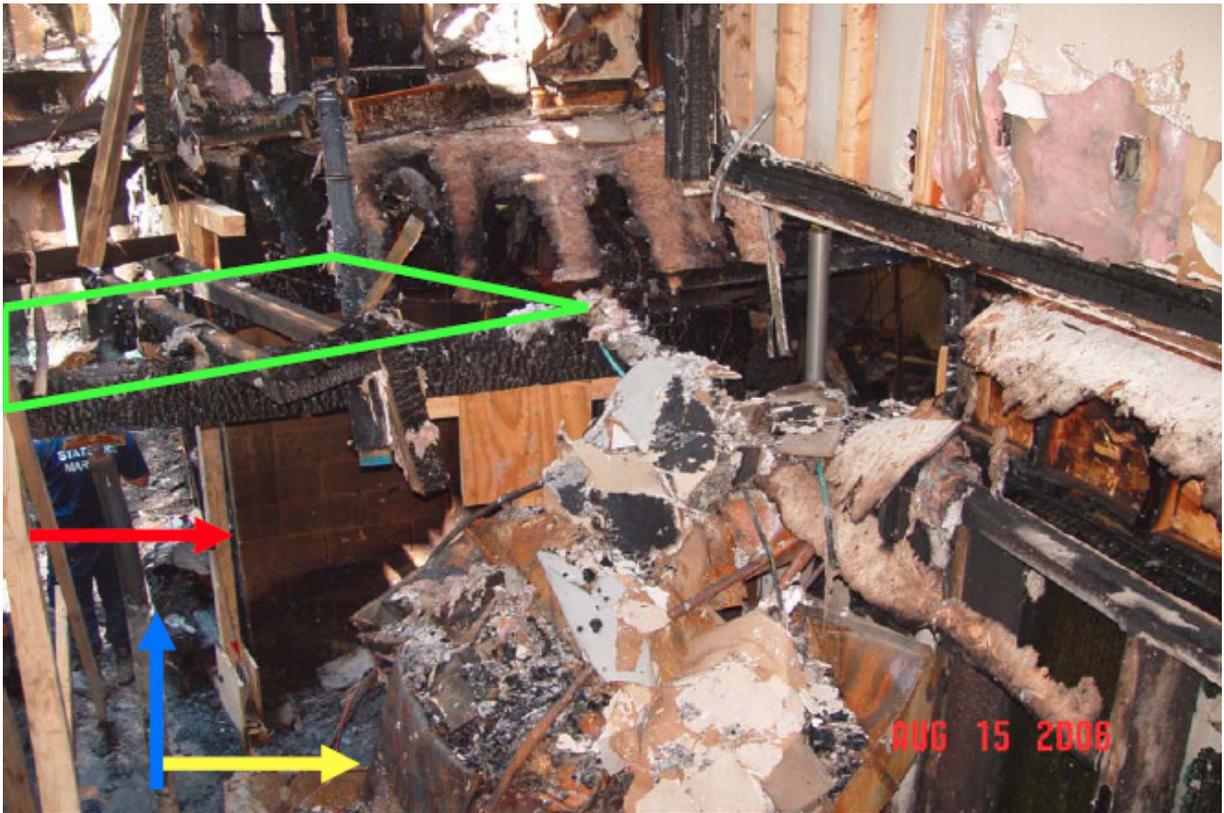
The photograph above is taken from the window with the American Flag. The yellow arrow shows the forced air furnace in the mechanical room below the office. The green box indicates the approximate location of where the floor collapse occurred to firefighters Wolff and Brinkley-Chaudoir. The red arrow below shows the chimney in the basement. The blue arrow shows the location of the work bench in the basement next to the chimney.

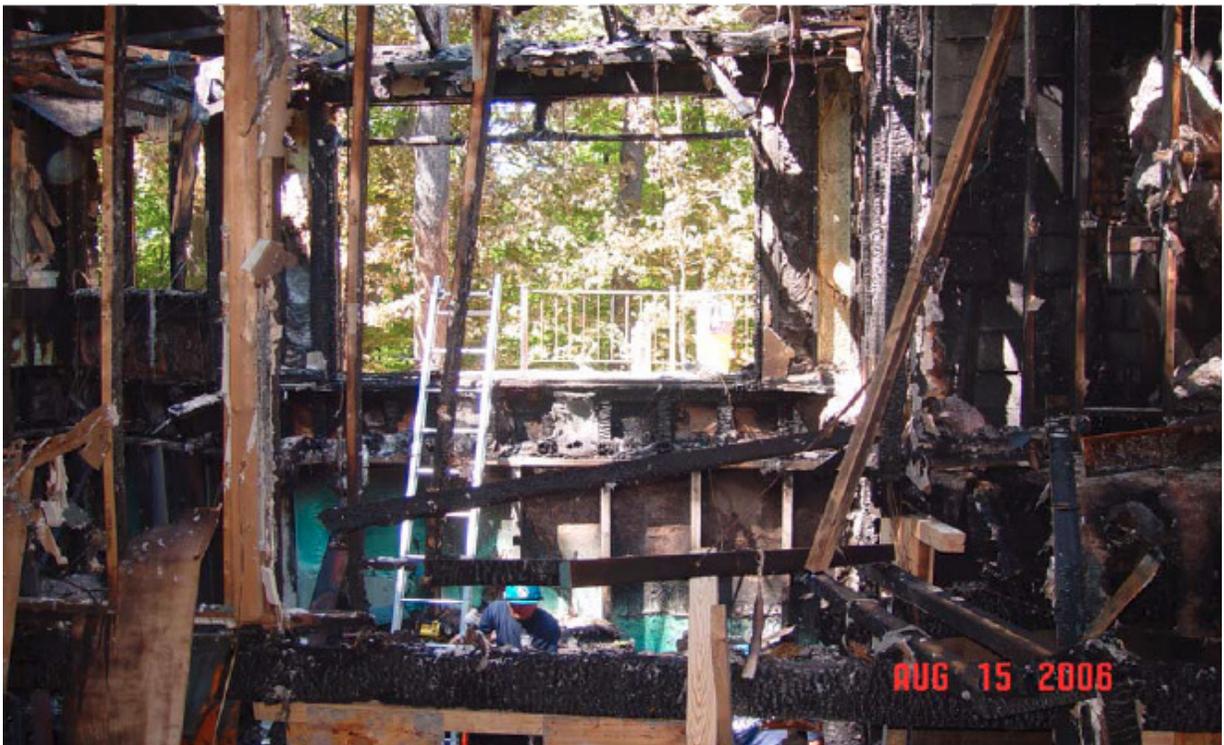
The photograph above is also taken from the office window. It shows where the floor of the master bedroom had collapsed.

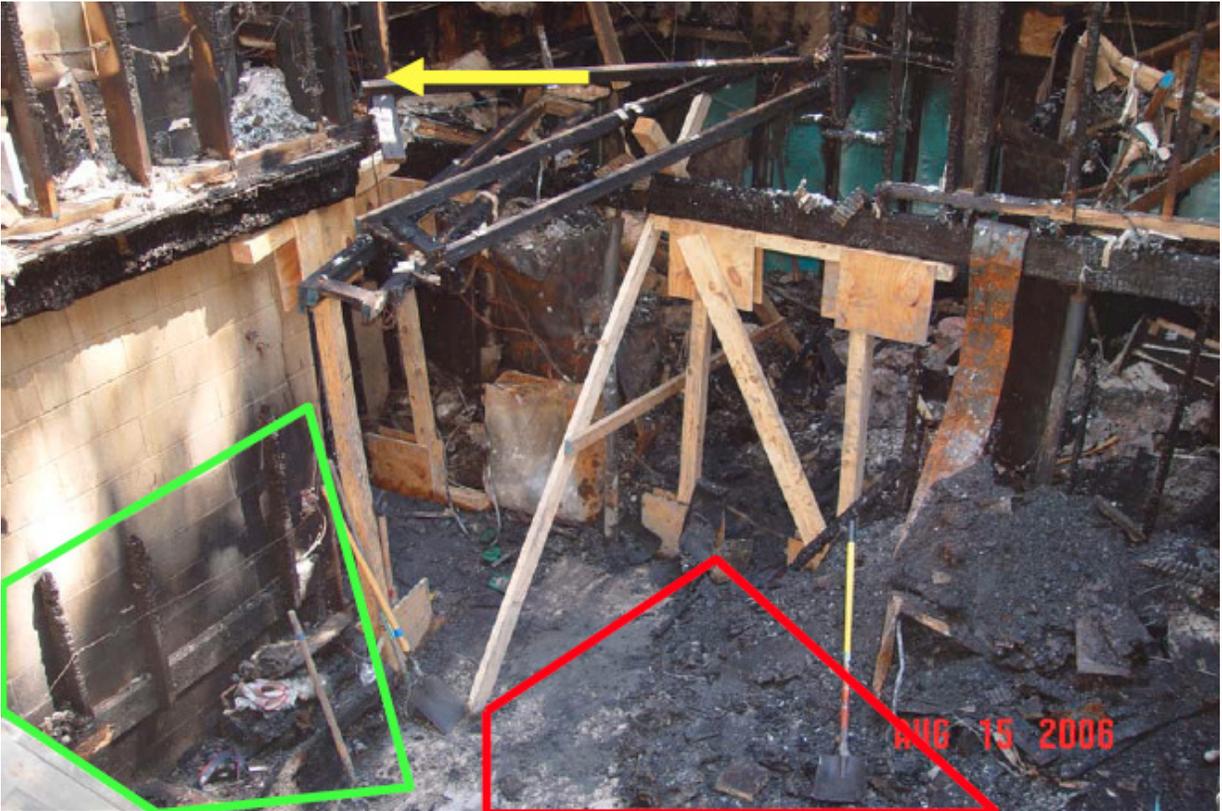
The photograph above is taken from the patio doorway of the master bedroom located on the north side of the structure (opposite the office window). The green box shows the workbench area along the chimney. Electrical conductors for the structure electrical system can be observed inside the green box. The yellow arrow shows the direction that firefighters Wolff and Brinkley- Chaudoir came from. The red box is the approximate location of where firefighter Wolff was recovered. *Jeff Kubitz Photo*

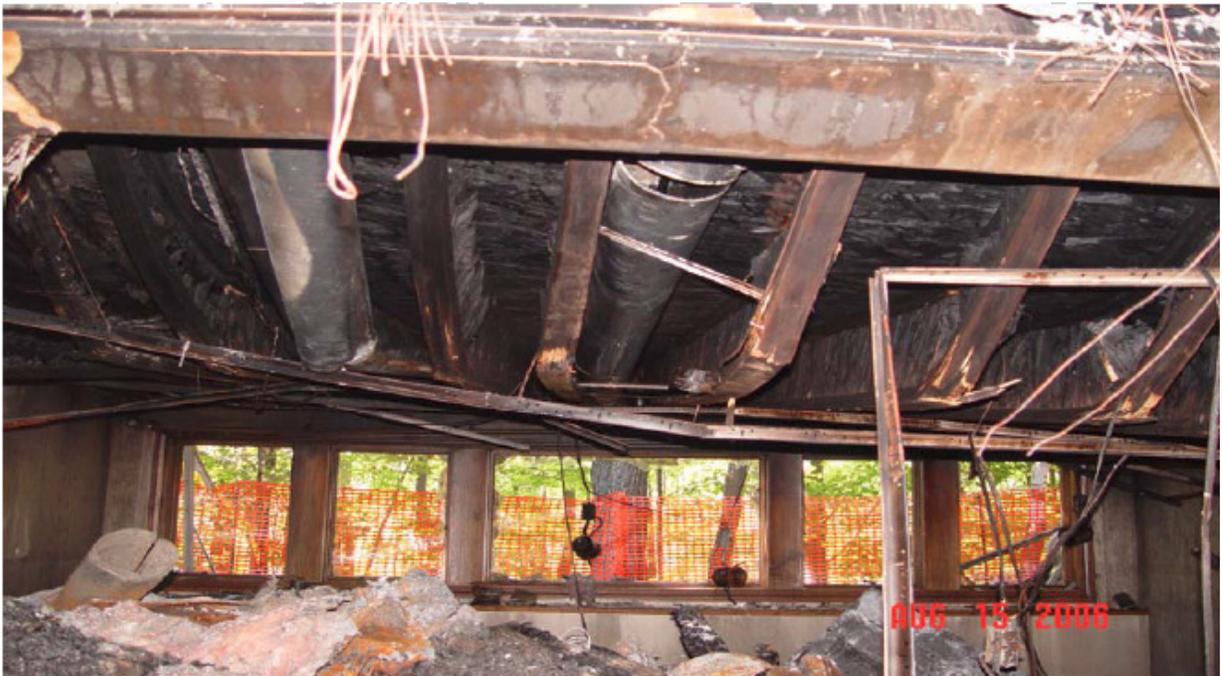
The photograph above is taken in the basement of the structure under the front entry and is showing the windows to the north of the entry and east of the chimney. This is where firefighter Brinkley-Chaudoir was rescued. *Jeff Kubitz Photo*

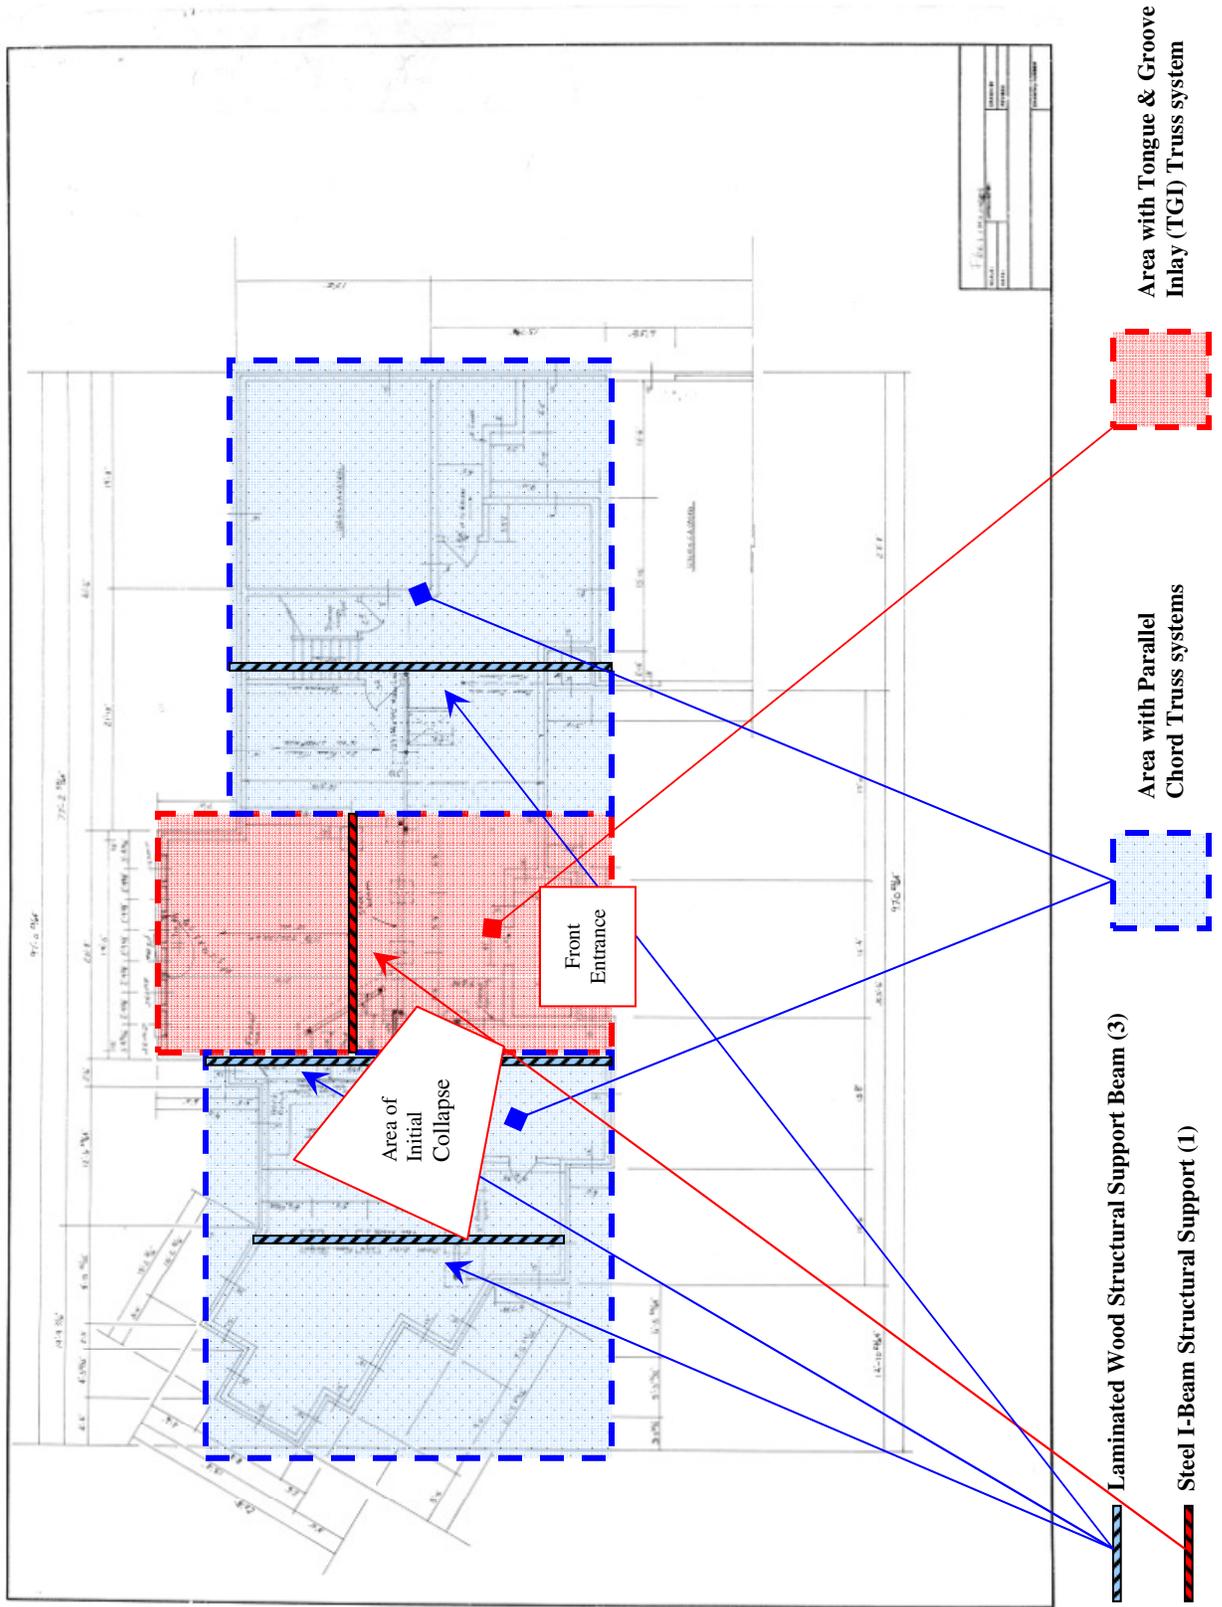
## Floor Support Detail for 438 Edgewood Drive

The area of catastrophic failure (Bravo side) at 438 Edgewood consisted of unprotected parallel chord trusses in an unfinished area of the basement. The time the fire progressed will never be known. When Ambulance 451 entered the structure to perform their search, the floor support system that failed had already been severely compromised, if not already failed.

The structural collapse can be attributed to two major factors. First, the time the fire progressed through the stages of incipient - to free burning - to failure – estimated to be six to 13 minutes of direct flame impingement, if not quicker due to the fire load and weight of the floor components. Items and materials stored in the room of origin most likely contributed to rapid fire spread. The timeframe cannot be determined to any degree of certainty because of the heavy fire damage to the area of origin. The second factor is the floor support system itself. The Parallel Chord Trusses were unprotected in this unfinished portion of the basement. In this case, which is common construction practice, lightweight trusses spanned large areas and the connecting web members transferred substantial loads to other parts of the truss. The Parallel Cord Truss system supported a sub floor of 3/4 inch tongue and groove OSB, with a 1 1/2 inch Gypcrete (30 lbs per sq ft.) with heating coils for an in-floor heating system, and substantial tile flooring.

Although this floor was built within the guidelines of the building code, the substantial load on the truss system in combination with the delayed detection of the fire caused the floor truss system to fail rapidly.

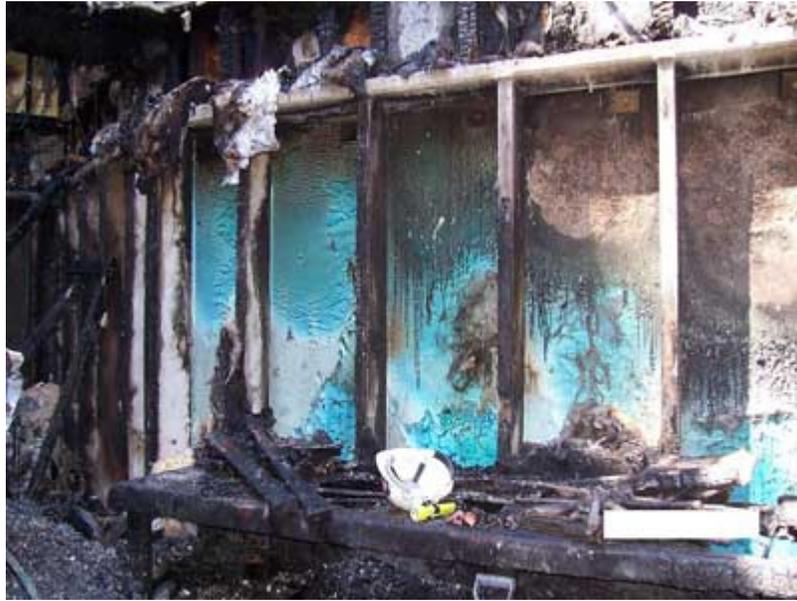
**Photo 1. Framed pre-cast walls with sheets of foam insulation**

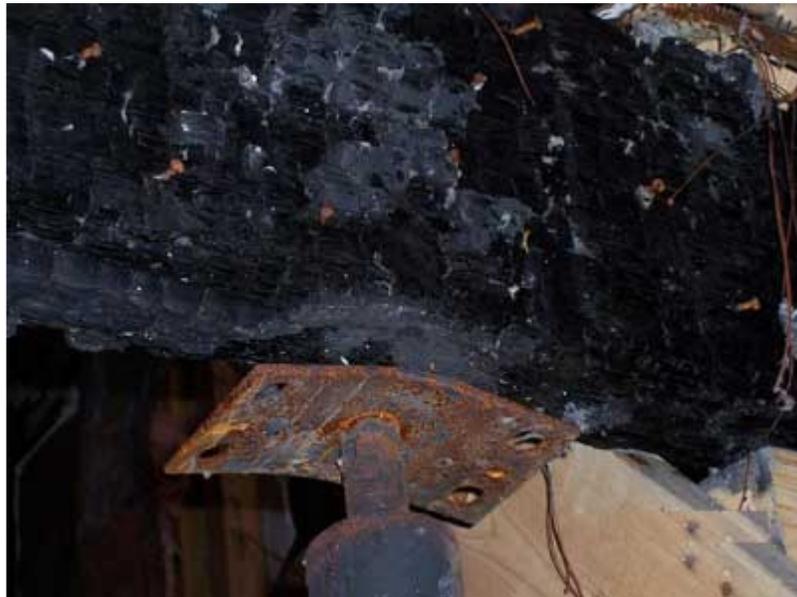
**Photo 2. Wooden beam and metal post jack**

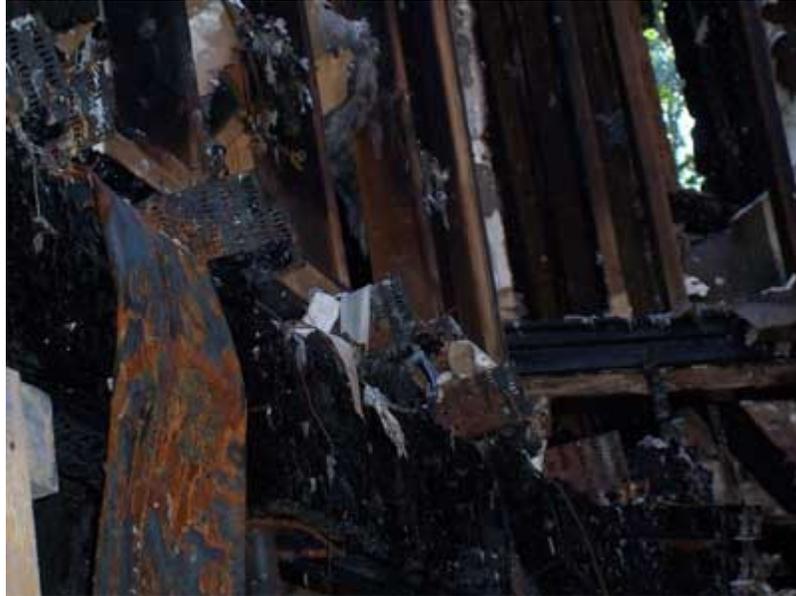
**Photo 3. Wooden beam and metal post jacks with bottom gusset plates from floor joists pinned to beam by first floor framing after entire floor joist consumed by fire.**

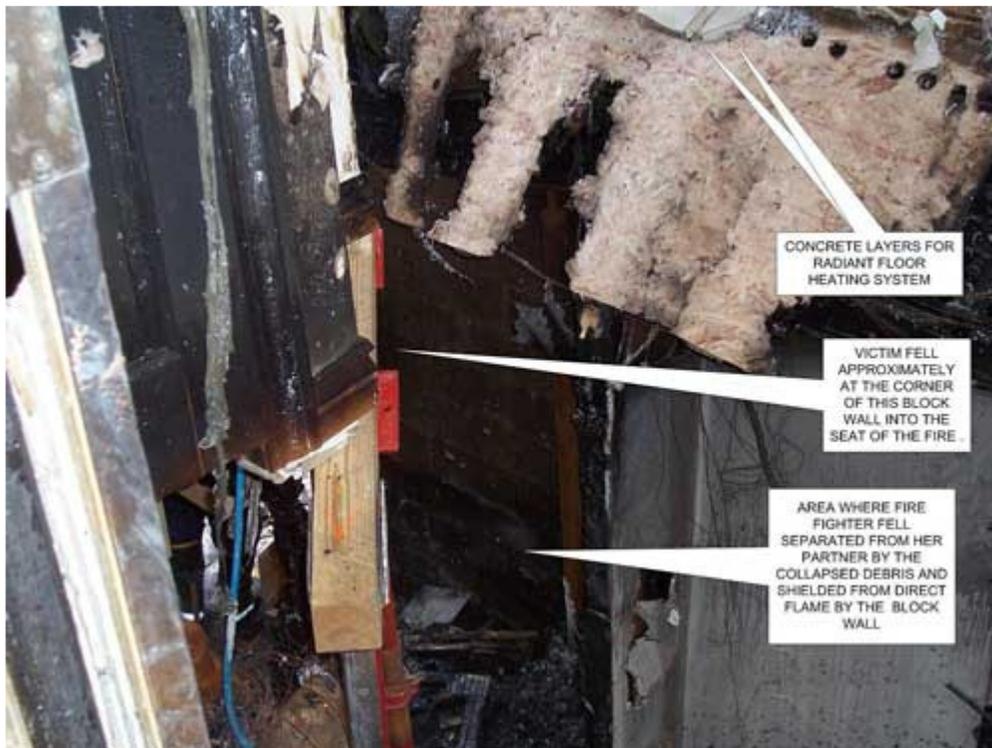
**Photo 4. Transition between foyer and hallway where floor collapsed**

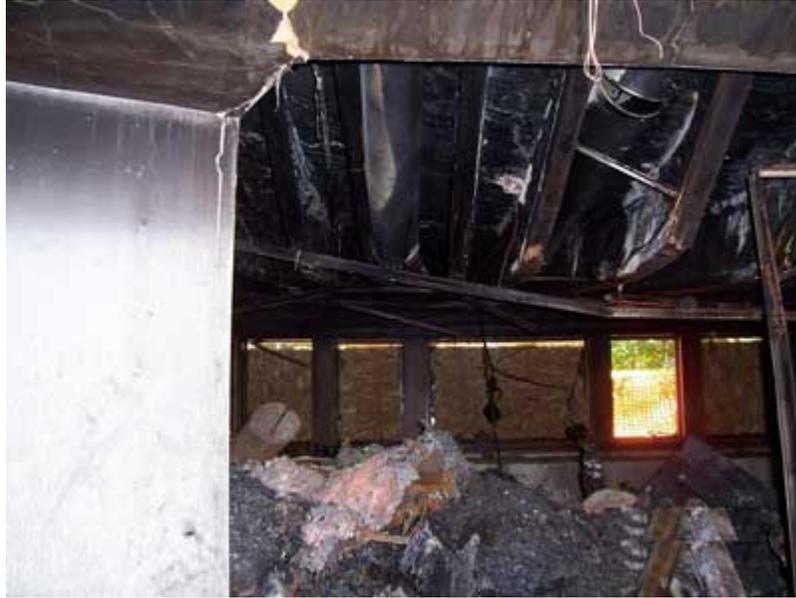
**Photo 5. Windows on C-Side of structure where fire fighter exited basement.**
