# Green Bay Fire Department Edgewood Analysis Team Incident #5747 Final Report

# FINAL REPORT #5747

438 Edgewood Drive, Green Bay, Wisconsin

August 13, 2006

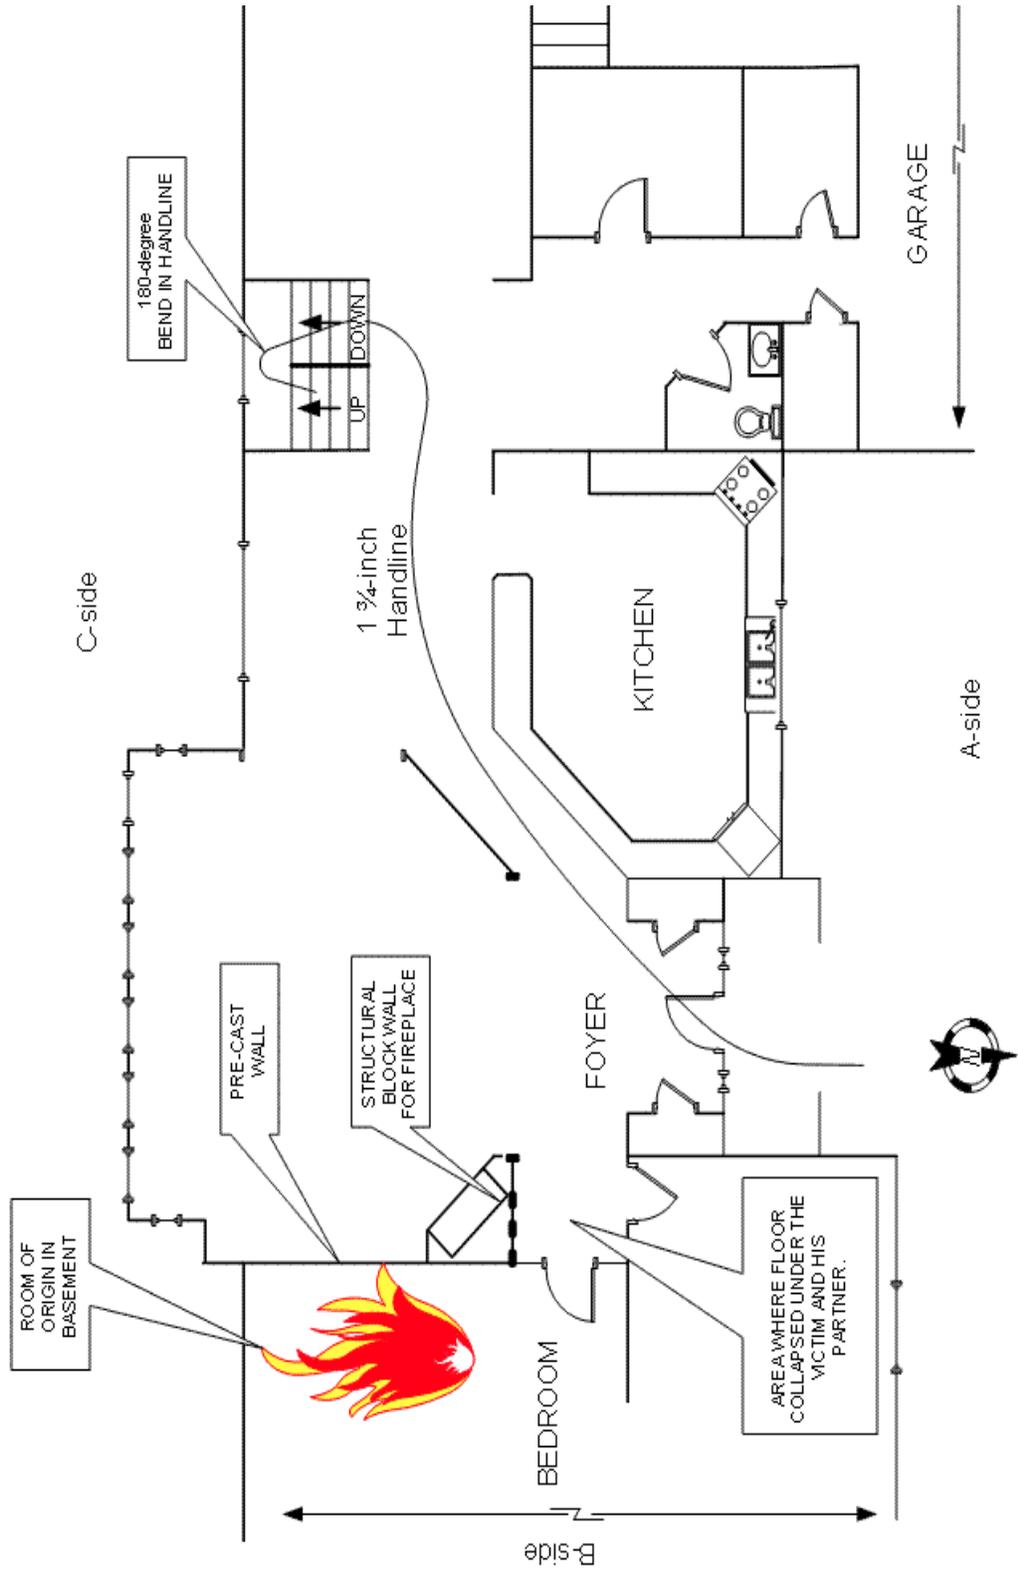
DIAGRAM  
 PARTIAL FIRST FLOOR LAYOUT  
 F 2006-26  
 AERIAL VIEW  
 RELEVANT SECTIONS ONLY

- Exterior: Cultured Stone over wood frame
- Foundation: 9' Prefab concrete sections bolted together
- 1st Floor trusses: Center "Cathedral Area" – 11 7/8" TGI Trusses, 12" O.C.
  - Side wings: 20" Wood Parallel Cord Trusses, 16" O.C.
- 2nd Floor trusses: 20" Wood Parallel Cord Trusses, 16" O.C. (Traditional 2 x 4)
- Flooring: Traditional OSB with carpet and/or ceramic tile
- Floor in area of collapse: OSB, heating coils, poured concrete, ceramic tile. Total = approximately 4 inches
- Interior walls: Dry wall over wood frame
- Support beams: 5 Micro-laminate beams
  - Three beams built into floor system
  - One steel beam in center of home
